Fort Hunt Road/Route 1 Crossing

Route 1 Merge to I-495/I-95 North

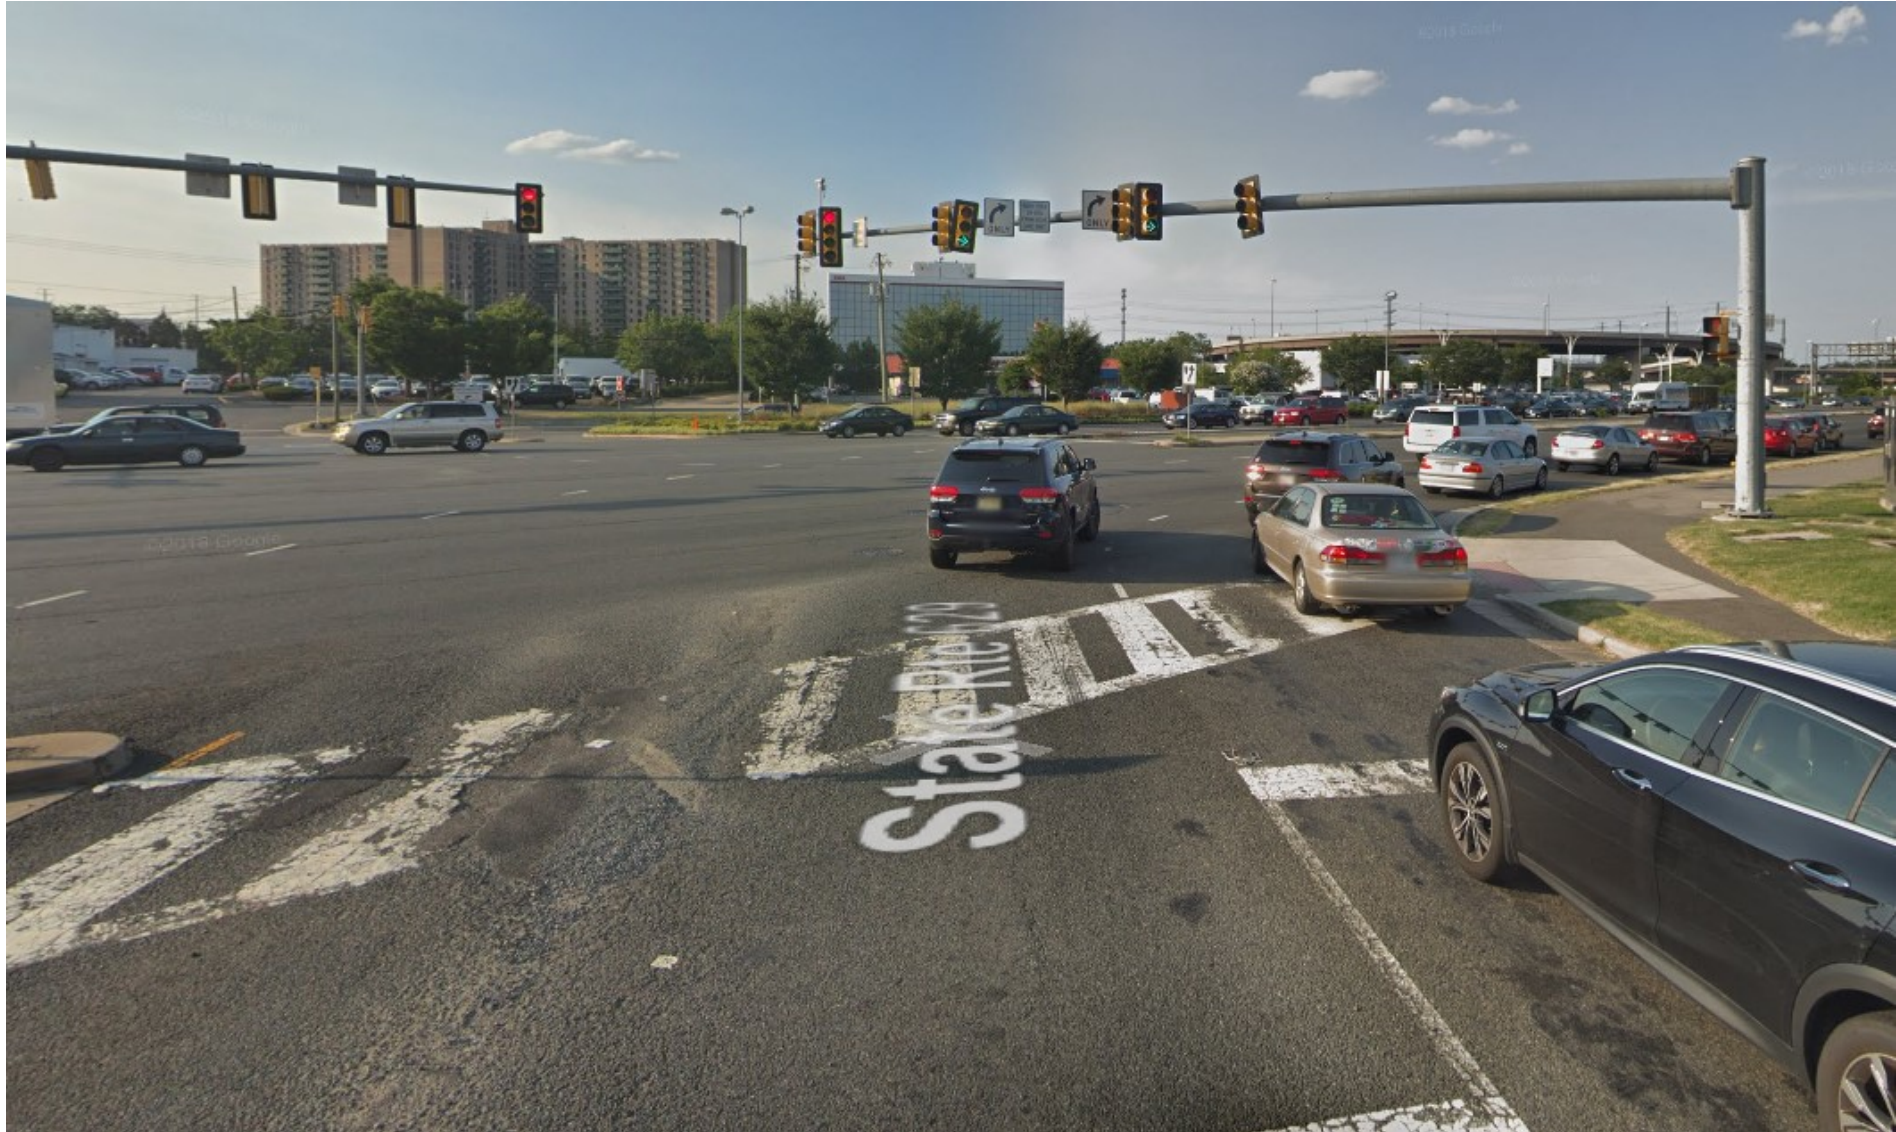
- Drivers on Fort Hunt Rd have a difficult time seeing how to cross Route 1 to access Old Richmond Highway, Ourisman Chevrolet, Ourisman Chrysler/Jeep/Dodge, Great America Steak & Buffet, etc.
- Center ridge on Route 1 “hides” the concrete island on the NW side of the intersection
- The entrance to Ourisman Chevrolet creates the illusion of a “street,” causing drivers to aim for that “street”
- Drivers have no dashed lane guides to help them stay on track to enter the street on the NW side of the intersection properly (to the right of the island)

- Recommended Corrections (Cheap Fix):
 - Add a dashed white lane guide from Fort Hunt Rd across Route 1
 - Add three or more vertical hard plastic guides OR a single, larger plastic “barrier” around the street sign
- Recommended Correction (More Expensive Fix):
 - Relocate the island on the NW side of the intersection
- Recommended Correction (Best Fix):
 - Enlarge the island to cover the entire area of the yellow “no-man’s land,” and include plenty of yellow caution barriers to assist drivers.

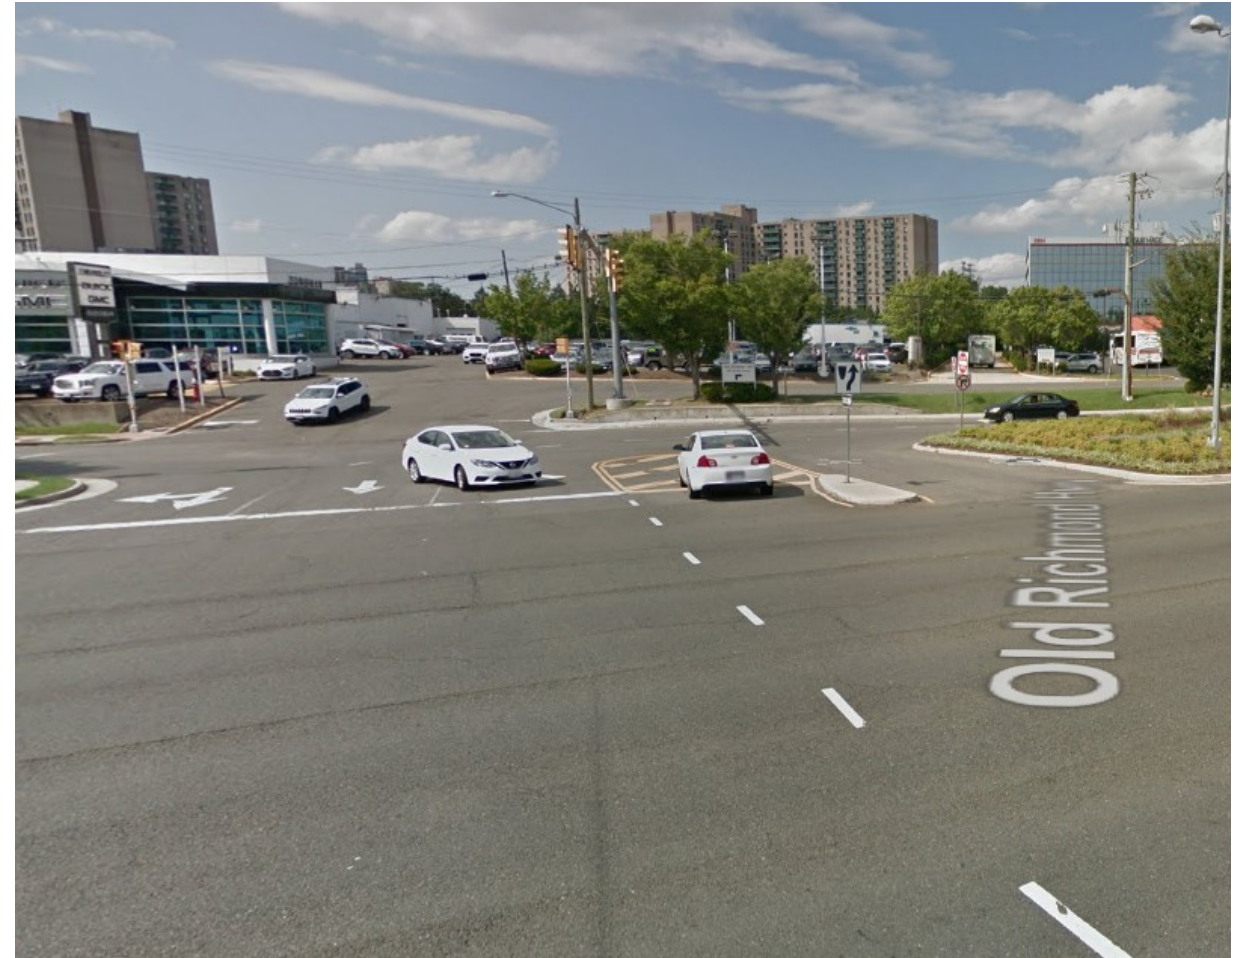
- Which causes problems like this...
- A couple things about this image:
 - The white car in the left turn lane shouldn't be there due to the "No Turn on Red" sign that governs northbound Old Richmond Highway
 - The Google Earth van was following the white car on the right, but corrected course in time to go to the right of the island.

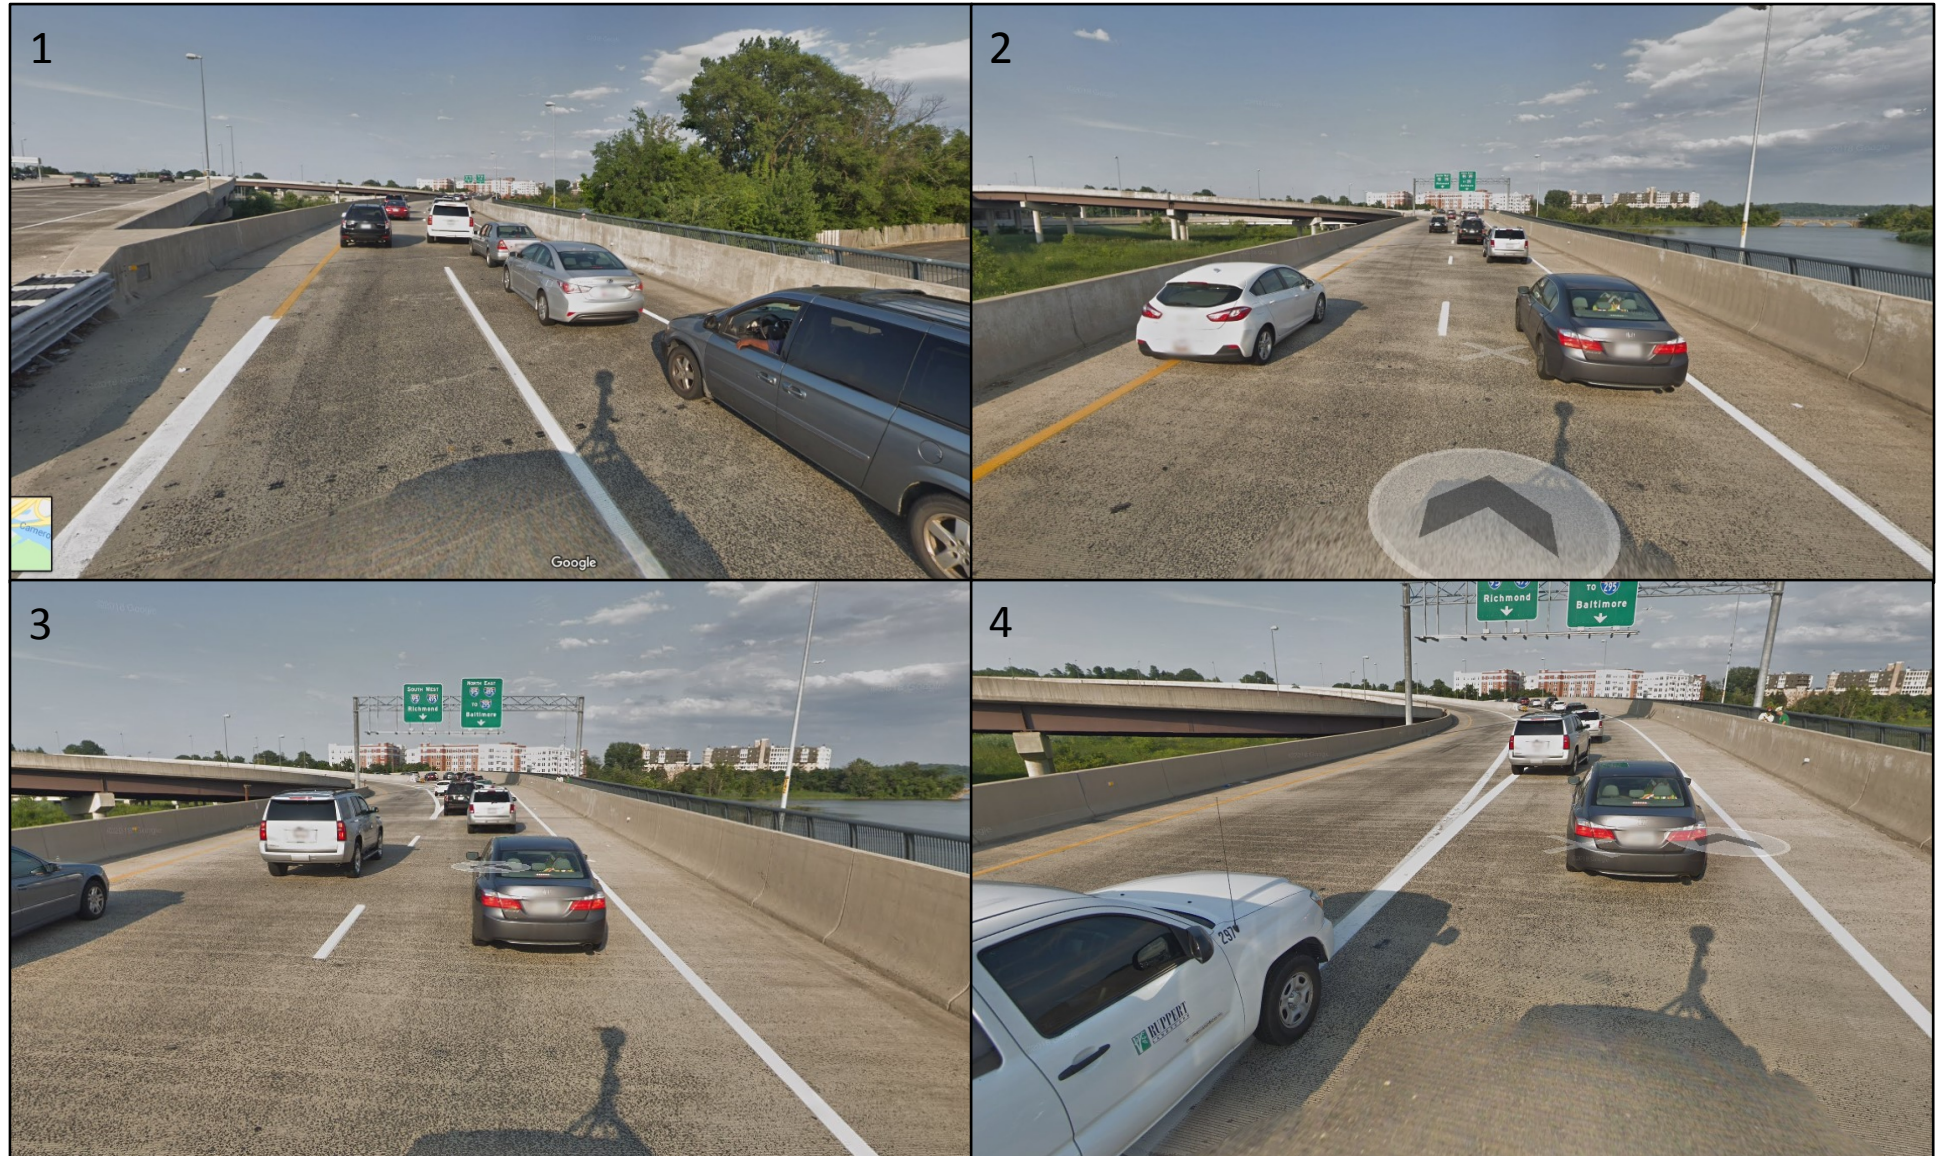
- Drivers on Route 1 headed to Maryland use the last 200 yards of roadway to merge from the I-495/I-95 South lane to the North lane, causing an accordion effect, which impedes traffic flow, causing Route 1 traffic to back up south of Huntington during peak periods, often as far south as the Red Roof Inn
- The roadway is currently painted to allow for these “last minute” lane changes
- However, most drivers ignore the painted roadway separation, illegally changing lanes within the last 30-60 feet before the concrete barrier.

- Image 1: Solid white line ends
- Image 2: Google Earth van merges right; note red car merging across the white island
- Image 3: Note the white car merging across the white island
- Image 4: Note the silver SUV merging at the last second, and the Ruppert Landscaping vehicle beginning to merge at the last second

- Recommended Corrections:
 - Change the dashed white line to a solid white line
 - Add yellow lane barriers (beginning point to be determined)
- Interim Fix:
 - Ask appropriate police organization to cite illegal lane changes

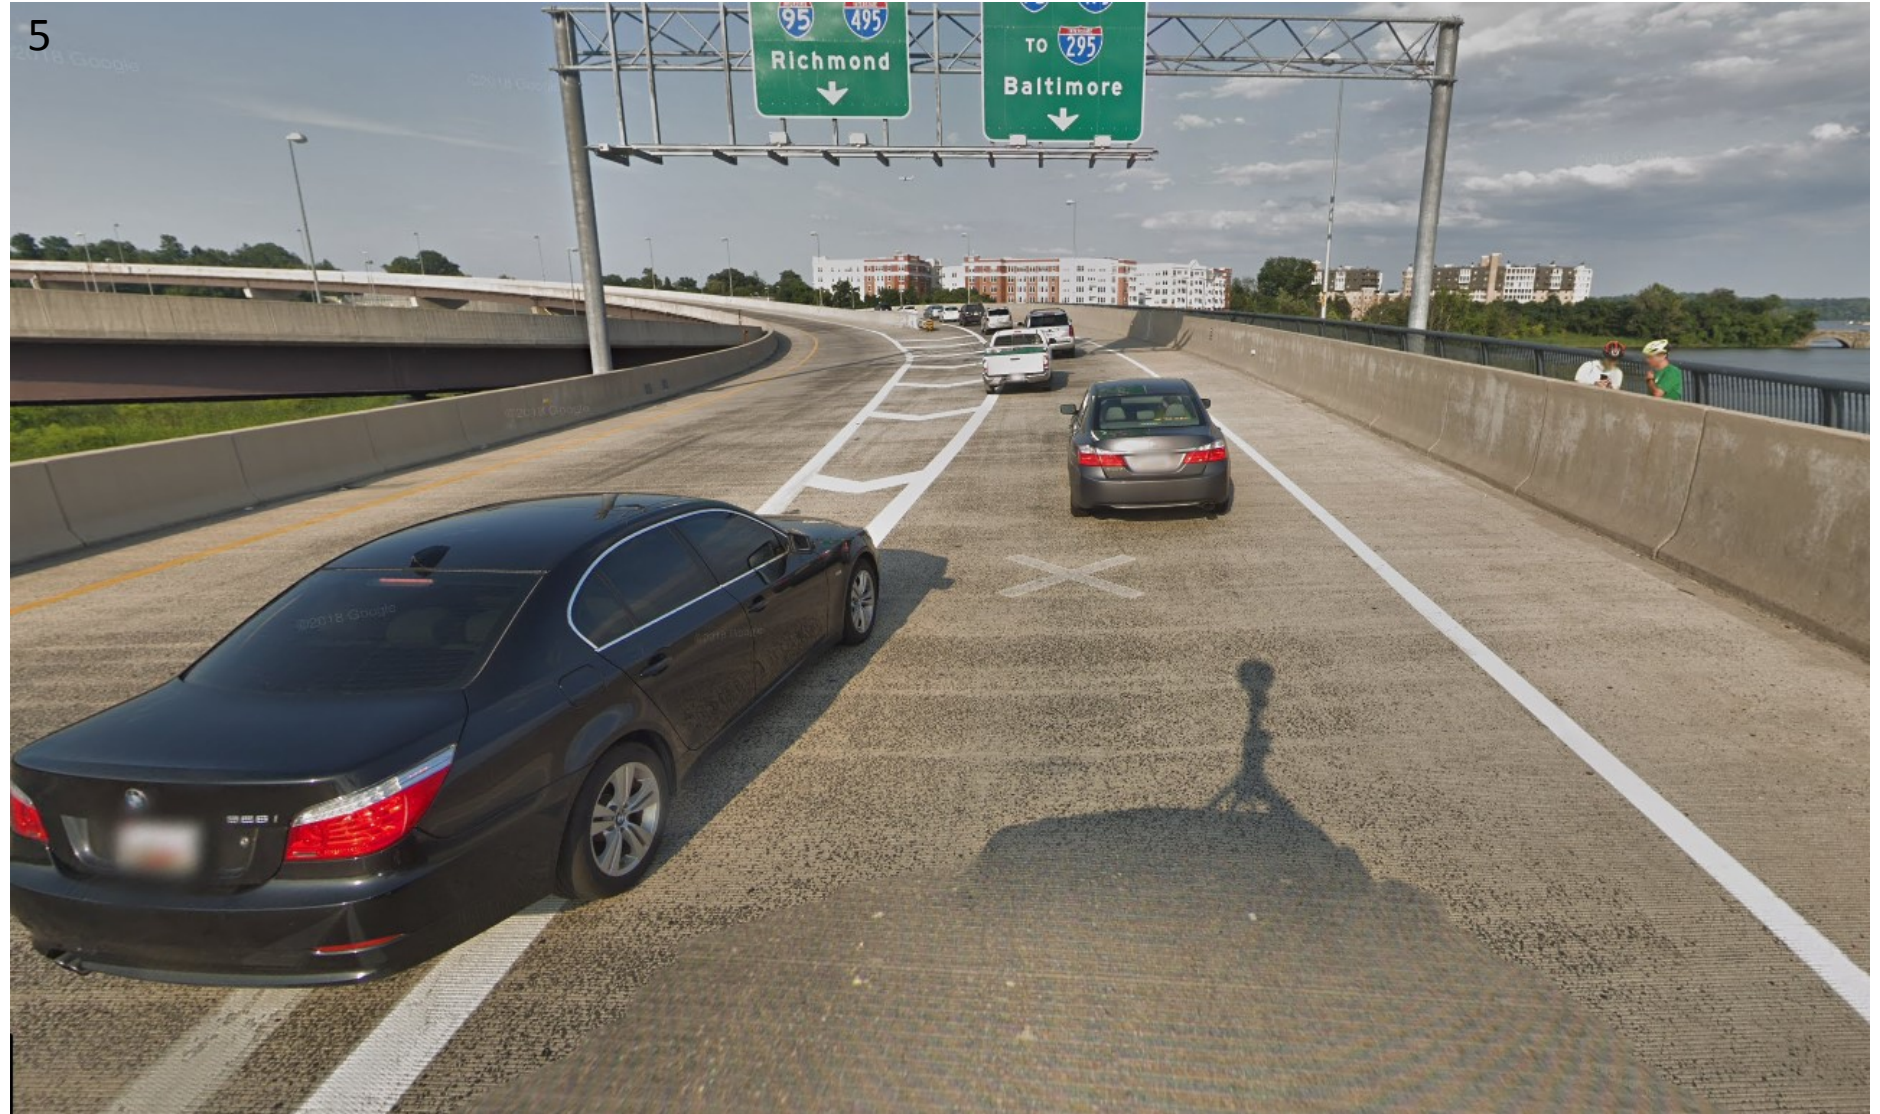
- Image 5: Note the BMW driver merging at the last second across the white island.
